Influence of weathering factors on durability of polymeric coatings used for concrete protection

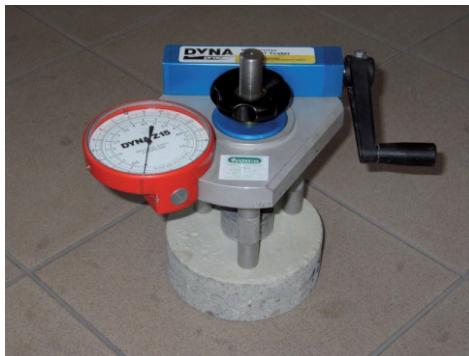
Fig. 1. Apparatus used for adherence tests.

Adherence to concrete was checked by means of Dyna 715 device. The tests were performed according to EN 1542:1999 standard (8). The coatings tested were deposited on concrete substrate and seasoned according to guidelines and after 24 hours the tests were done. Fig. 1 shows the apparatus used for adherence tests.

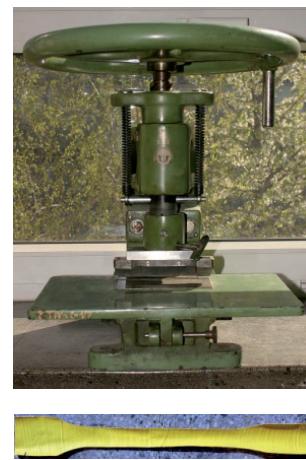
Fig. 2. Machine used for cutting out the samples and the picture of sample obtained

Studies of changes in elongation of coating foils as a result of weathering were done using ZWICK 1445 universal machine according to PN-81/C-89092 standard (9). The coatings were prepared in the form of foils and their thickness was around 140 nm. Then the samples have been prepared using the special device for cutting out samples from polymeric foils as shown on Fig. 2.

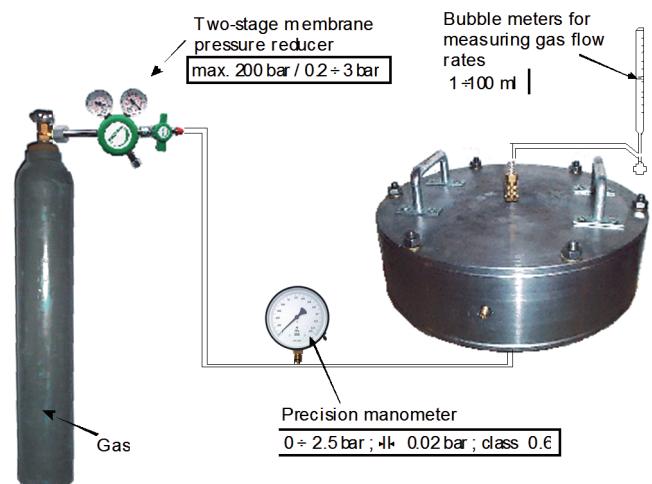
Fig. 3. Scheme of the apparatus for testing the permeability by means of Cembureau method (10)

Permeability to carbon dioxide was determined in accordance with the RILEM-Cembureau method. The measurements were carried out using the apparatus shown in Fig. 3. Cylindrical concrete samples were used in all tests. The specimens were 150 mm in diameter with the thickness of 50mm. The coatings were deposited on these concrete substrates and seasoned for one week.

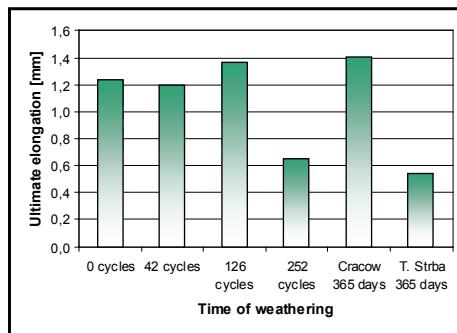
Fig. 4. Ultimate elongation of EP coating before and after weathering

observed during both natural and artificial changes. Adherence of both coatings was much higher than required (5). Deformability was determined during tensile strength tests. Fig. 4 and 5 present test results (mean values).

As a result of weathering of EP coatings, their ultimate elongation did not change significantly in comparison with initial samples apart from the ones weathered for one year in Tatranska Strba and for 252 cycles in the chamber. The reduction of ultimate elongation of the specimens can be explained by the fact that they have been exposed to UV for a long time and epoxy resins are known to be rather poorly resistant to the action of ultraviolet light. In general, the material showed low deformability and weathering caused the significant increase in its brittleness and fragility. These results are confirmed by the pictures presented below, showing numerous micro-scratches after 252 cycles (Fig. 6).

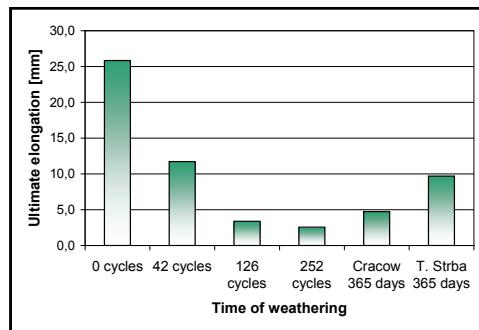
Fig. 5. Ultimate elongation of PU coating before and after weathering

Weathering of PU coatings caused progressing decrease in ultimate elongation regardless of the place of aging. The longer the time of weathering in the chamber, the higher the decrease in the

elongation of samples was observed. In the case of weathering under natural environment, more significant reduction of the elongation was noticed for the samples from Cracow than the ones from Tatranska Strba.

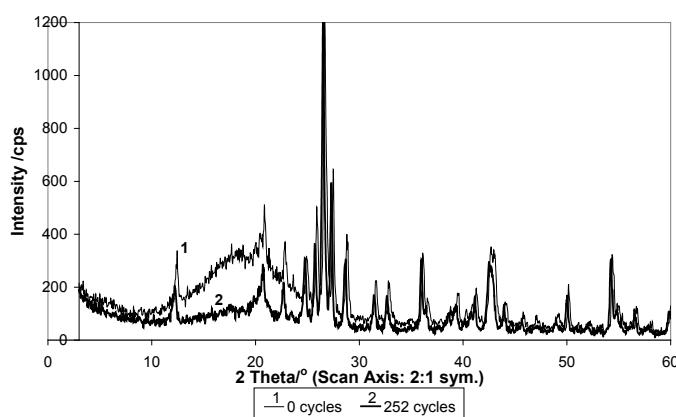
Fig. 7. Diffraction pattern of EP coating before and after 252 cycles of artificial weathering

The XRD tests were performed using Philips PW 1830 device. The study dealt with analysis of EP and PU coatings before and after 252 cycles of artificial weathering. The aim of the study was to check whether, after weathering, any new crystalline phases were formed in the structure of the materials. Moreover, by means of XRD, it was possible to identify different inorganic compounds such as fillers and pigments commonly added to coatings.

4. Both natural and artificial weathering lead to an increase in permeability of coatings tested. Nevertheless, the increase can be caused by higher stiffness of coatings after weathering and formation of micro-cracks.
5. XRD analysis showed that no new crystalline phases formed during weathering.
6. FTIR analysis allowed determining cause of changes of mechanical properties of coatings. It seems that a decrease in deformability was connected with stiffening of structure as a result of oxidation processes and formation of extra carbonyl groups.
7. The test results showed that weathering had much higher influence on the barrier properties of EP coating than on the properties of PU coat. Especially the artificial weathering caused dramatic loss of required properties of EP coating.

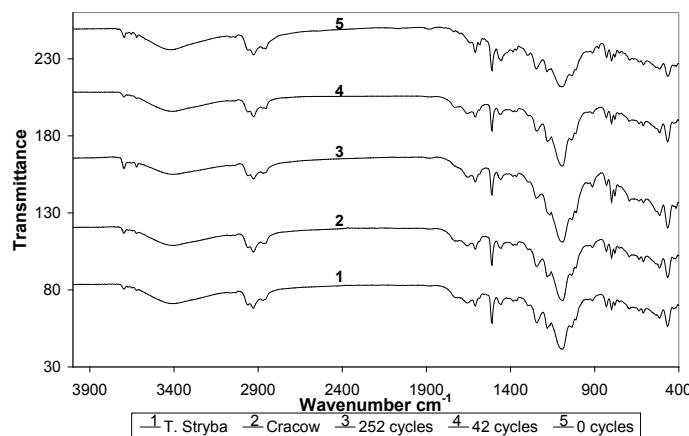
Fig. 9. Spectra of EP coatings before and after weathering

FTIR measurements were performed using BIO-RAD FTS 175C device. Spectra of samples were recorded using KBr pastille technique. Initial spectra were compared with spectra of specimens after weathering and then, comparing characteristic functional groups of given coating, an attempt was made to explain changes in the structure of the coats.

cm^{-1} confirms such suggestion. The length of hydrocarbon chain is connected with elasticity of coating. The longer the chain, the higher the elasticity is. Degradation of the chain causes higher stiffness of structure, which was confirmed in mechanical experiments. Changes in intensity of the band at around 3400 cm^{-1} can be connected with the presence of OH^- groups connected with alcohols. Changes in $2850\text{-}3000 \text{ cm}^{-1}$ region can be prescribed to CH_3 , CH_2 and CH groups formed as a result of degradation.
