# Testing of reinforced AAC walls under lateral and racking loads

**ABSTRACT:** Reinforced AAC panels in the UK have been used in past, but these tended to be acting as roof units and to a limited extent floor units, with walling elements occasionally used horizontally as fire walls or thinner vertical elements for partitions. In more recent times, their use in housing has been explored as a series of vertical storey height, solid wall elements (each element being 600 mm wide) to form the outer fabric of construction. In this form of construction a thickness of 200 mm will act as the main load-bearing component of the structure as well as making a significant contribution to the overall thermal performance of the building.

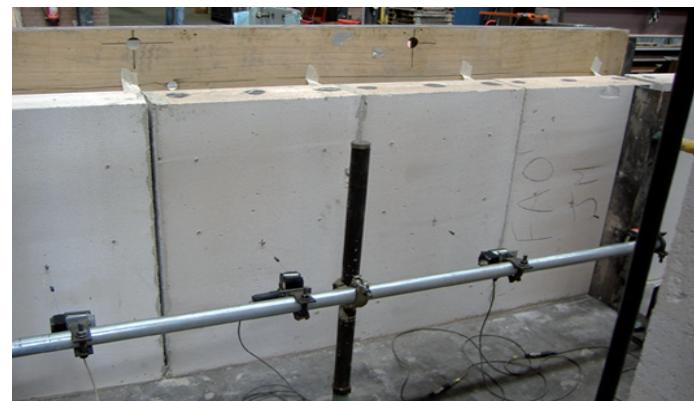
Fig. 2. General View of Test Arrangement and Failure of Wall 1 under Horizontal Spanning Test.

The results of the loads at failure are quite variable. In test one failure was at the mortar joint at the left hand side of the panel, in the latter two it was by the unit failing close to the centre of the panel (see figures 2 and 3). The loads at failure indicate that at the

failure in panel 1 the bending moment across the joint was 2.4 kN-m whereas the maximum in the panel at mid span was 3.7 kN-m. In panels 2 and 3 the maximum bending moment was 4.8 kN-m and 5.8 kN-m respectively. Consequently in panel 1 the first joint resisted less than half the moment that was carried by the central joint before failure of the block close to the central joint in subsequent tests. The deflections indicate that in panel 1 the displacement was quite asymmetrical with the left hand panel displacing far less than the right hand or naturally the centre panels. All of the panels were very stiff with maximum deflections at failure no more than approximately span/1200 and deflections at working load much less (see figures 4-6). The relative stiffness of the left hand side of panel 1 and relatively low failure moment is obviously a matter of concern. Clearly three specimens is insufficient to derive a statistically meaningful lower bound bending capacity and with the data we have we would be forced to conclude a low characteristic or representative lower bound. Naturally the joint in question in panel 1 may have been in some way unusual or deflective, alternatively perhaps some low load cycling might have helped with ‘bedding in’ and made the deflected profile more symmetrical and the failure load to be nearer to that of the remaining two panels.

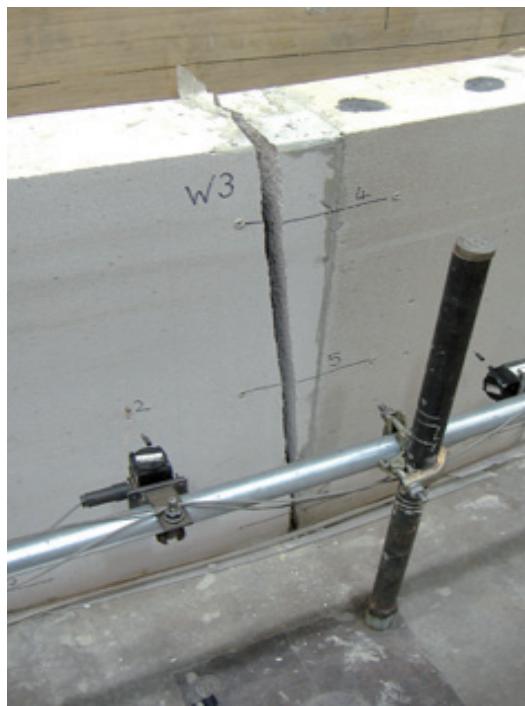
Fig. 3. Failure of Wall 3 under Horizontal Spanning, Note the Unit Failure and not Mortar Joint Failure.
